**Flood Control Project Maintenance
Levee Inspections**

Maintenance Issue Types Only, Levee Inspection Report By Mile - Spring 2019

Sutter Maintenance Yard Murphy Slough at M&T Ranch

Waterway	Bank	Unit Miles	Inspection Start/End	Inspector
Unit No. 01 Murphy Slough at M&T Ranch	Left	0.83	05/14/2019 05/14/2019	Makar Sokol

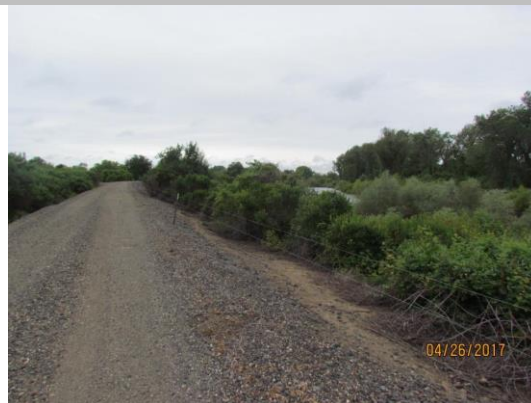
Photo 1 of 1 : SP_2019_ST0014_372_1_20190327_00001.jpg

LM Start	0.00	Rating **	M	Issue No.	1
LM End	0.09	Issue Type +	Ma	Location *	WS
Category	Earthen Levee			GPS Latitude/Longitude	
				Start	End
Item	Vegetation			39.667748 °	39.666836 °
				-121.959205 °	-121.960897 °
DWR ID	DWR_NA0014_01_s_2012_1				
Comment Code					
V4 : Elderberries are blocking visibility and flood fight capability.					
Inspector Comment

View of the elderberries along the waterside toe.

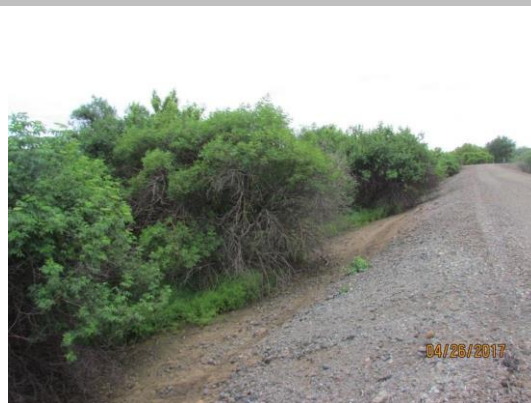
Photo 1 of 1 : SP_2019_ST0014_372_4_20190327_00002.jpg

LM Start	0.00	Rating **	M	Issue No.	4
LM End	0.09	Issue Type +	Ma	Location *	LS
Category	Earthen Levee			GPS Latitude/Longitude	
				Start	End
Item	Vegetation			39.667748 °	39.666983 °
				-121.959205 °	-121.960997 °
DWR ID	DWR_NA0014_01_s_2012_4				
Comment Code					
V4 : Elderberries are blocking visibility and flood fight capability.					
Inspector Comment

View of the elderberries along the landside toe.

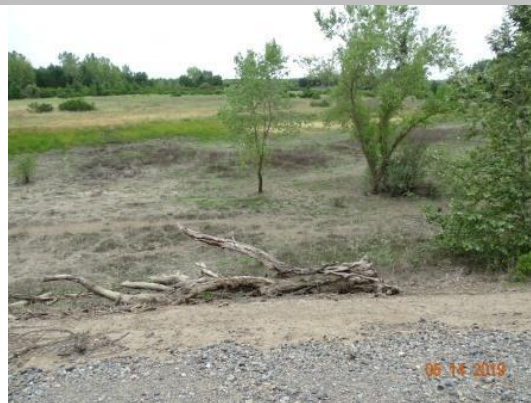
Photo 1 of 1 : SP_2019_ST0014_372_8_20190520_00003.jpg

LM Start	0.31	Rating **	M	Issue No.	8
LM End	0.31	Issue Type +	Ma	Location *	LS
Category	Earthen Levee			GPS Latitude/Longitude	
				Start	End
Item	Encroachments			39.666319 °	39.666319 °
				-121.964544 °	-121.964544 °
DWR ID	DWR_ST0014_01_s_2019_8				
Comment Code					
TR : Tree or limb					
Inspector Comment					
The tree should be removed from the landside toe.

View of the tree at the landside toe. Spring 2019.

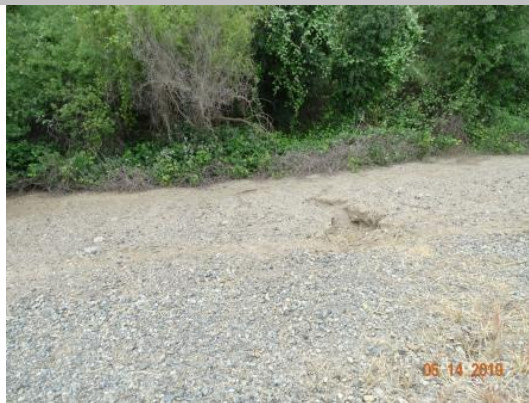
Photo 1 of 1 : SP_2019_ST0014_372_5_20190520_00004.jpg

LM Start	0.56	Rating **	M	Issue No.	5
LM End	0.56	Issue Type +	Ma	Location *	LS
Category	Earthen Levee			GPS Latitude/Longitude	
				Start	End
Item	Erosion / Bank Caving			39.667026 °	39.667026 °
				-121.968890 °	-121.968890 °
DWR ID	DWR_ST0014_01_s_2019_5				
Comment Code					
E2 : Schedule repair of erosion site prior to the next inspection.					
Inspector Comment

View of the erosion on the landside slope. Spring 2019.
